**Flood Control Project Maintenance
Levee Inspections**

Fall 2018 Levee Maintenance Deficiency Summary Report

San Joaquin River Basin

Reclamation District No. 2075 McMullin

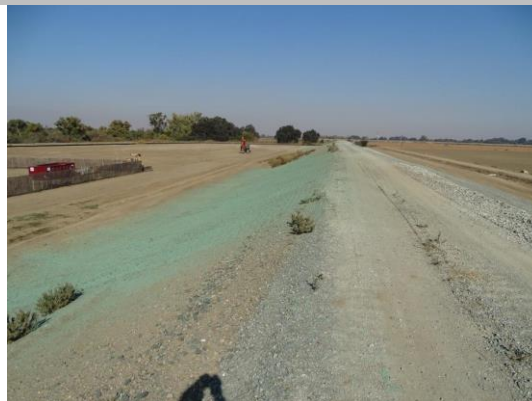
Photo 1 of 1 : FA_2018_RD2075_315_30_20181126_00067.jpg

Typical view of levee along waterward slope. (Fall 2018)

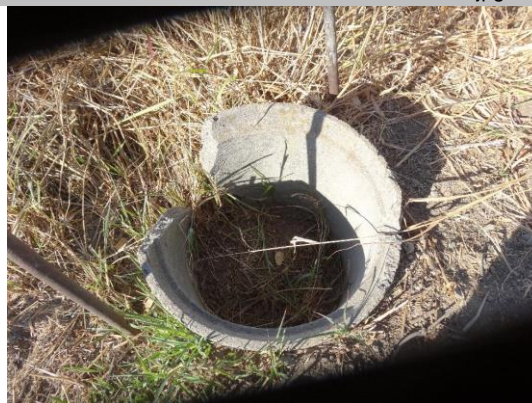
Photo 2 of 3 : UCIP_FA_2018_24663_44021.jpg

Comment Code					
Inspector Comment					
FS_ID:24663 DS_ID:24735 EP_NO: 4736 Repair Type: Non-Urgent Crossing Status: Found UCIP Comments: - pipe not visible on waterside.- no access to concrete riser on waterside.- blocked siphon breaker. FIELD_STRUCT_DESC: 14-inch coated steel drainage discharge pipe through the levee, 4 feet below the crown. Two concrete cutoff walls. Pump mounted on a pile structure in the drainage ditch on the landside (LS). Siphon breaker in a concrete riser on the waterside (WS) slope. Concrete distribution box at the WS toe. (Plans for removing and replacing an existing drainage pipe through the levee authorized under Permit No. 4736, 1964 - Reclamation District No. 2075). [Additional Reference(s): DWR Levee Log, 2005, 12-inch pipe referenced. USACE San Joaquin O&M Manual 3, December 1968, (HLM 0.12), 12-inch pipe referenced]. FS Date: 11/13/2013

WS view: concrete pipe riser with siphon breaker on levee slope.

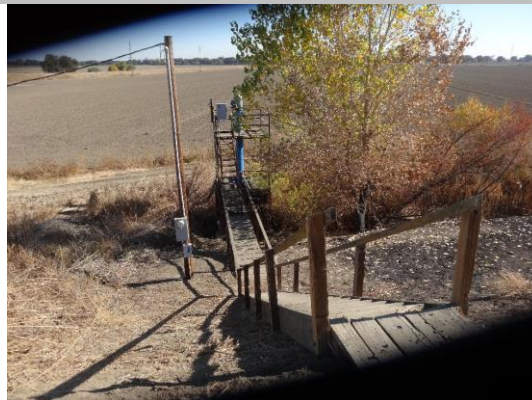
Photo 3 of 3 : UCIP_FA_2018_24663_44020.jpg

Comment Code						
Inspector Comment						
FS_ID:24663 DS_ID:24735 EP_NO: 4736 Repair Type: Non-Urgent Crossing Status: Found UCIP Comments: - pipe not visible on waterside.- no access to concrete riser on waterside.- blocked siphon breaker. FIELD_STRUCT_DESC: 14-inch coated steel drainage discharge pipe through the levee, 4 feet below the crown. Two concrete cutoff walls. Pump mounted on a pile structure in the drainage ditch on the landside (LS). Siphon breaker in a concrete riser on the waterside (WS) slope. Concrete distribution box at the WS toe. (Plans for removing and replacing an existing drainage pipe through the levee authorized under Permit No. 4736, 1964 - Reclamation District No. 2075). [Additional Reference(s): DWR Levee Log, 2005, 12-inch pipe referenced. USACE San Joaquin O&M Manual 3, December 1968, (HLM 0.12), 12-inch pipe referenced]. FS Date: 11/13/2013

LS view: walkway, pump, service pole, and intake structure.

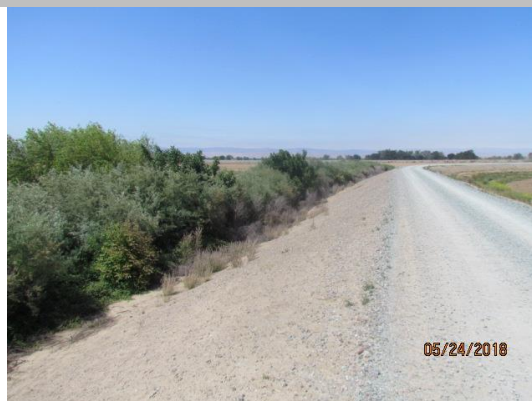
Photo 1 of 3 : FA_2018_RD2075_315_29_20180906_00042.jpg

Looking west at dense veg at landward toe. (Spring 2018)

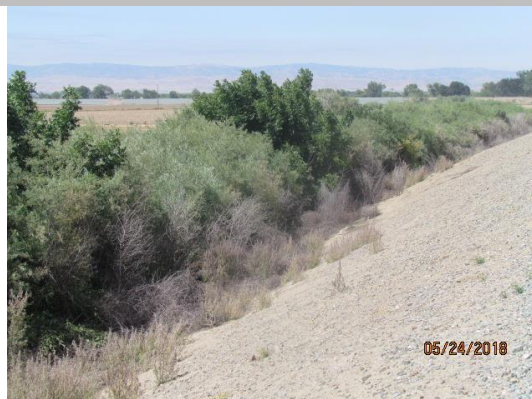
Photo 2 of 3 : FA_2018_RD2075_315_29_20180906_00043.jpg

LM Start	1.43	Rating **	U	Issue No.	29 (cont)
LM End	1.63	Issue Type +	Ma	Location *	LS

Looking west at dense veg. at landward toe. (Spring 2018)

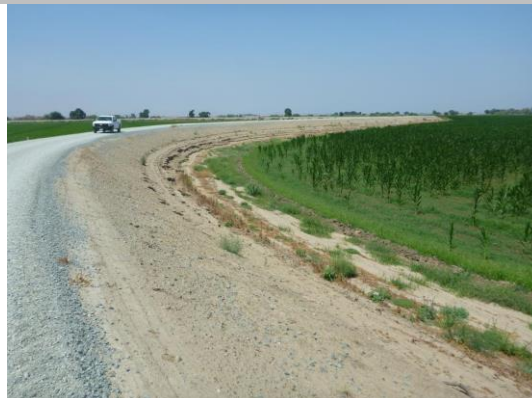
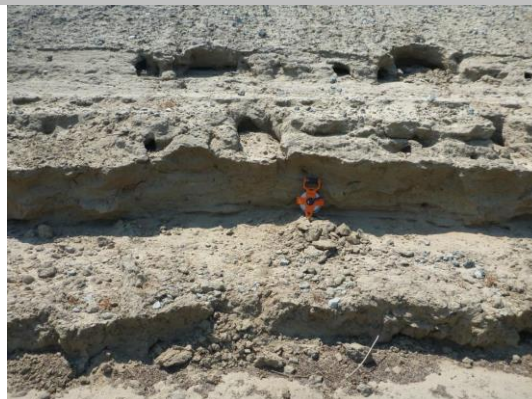
LM Start	1.58	Rating **	M	Issue No.	12 (cont)
LM End	1.67	Issue Type +	Ma	Location *	WS
Category	Supplemental			GPS Latitude/Longitude	
				Start	End
Item	2017 Storm Damage			37.734353 °	37.734463 °
				-121.286720 °	-121.288258 °
DWR ID	DWR_RD2075_01_f_2017_12

Description: Slope protection repairs are needed along the waterside slope due to erosion and riprap displacement from high water. Based upon levee inspections, it was determined the waterside levee slope is eroding, deteriorating, and degrading. The eroded levee sections need to be restored back to design standards to prevent further deterioration and damage.

Notes: 10/23/17: According to LMA and my observations at LM 1.63, this site never had riprap (contrary to previous comments). Erosion has encroached into levee prism. Future high water and wavewash will likely advance erosion further into prism. Repairs should be made prior to next high water.

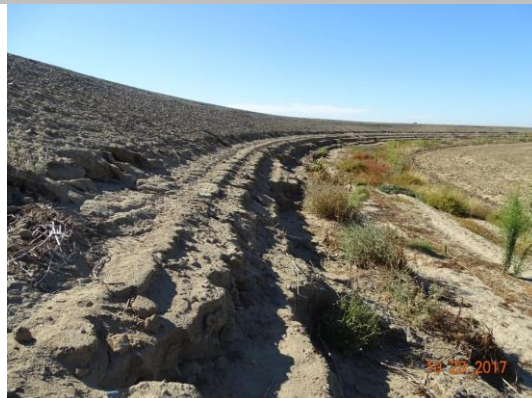
Photo 4 of 4 : FA_2018_RD2075_315_12_20180906_00007.jpg

Item	2017 Storm Damage		37.734353 °	37.734463 °						
			-121.286720 °	-121.288258 °						
DWR ID	DWR_RD2075_01_f_2017_12									
Comment Code										
Inspector Comment										
<p>Levee Evaluation Comments</p> <p>Description: Slope protection repairs are needed along the waterside slope due to erosion and riprap displacement from high water. Based upon levee inspections, it was determined the waterside levee slope is eroding, deteriorating, and degrading. The eroded levee sections need to be restored back to design standards to prevent further deterioration and damage.</p> <p>Site ID No: 575</p> <p>Site Designation: LMA-481</p> <p>Repair Type: Erosion</p> <p>Rating: Area of Concern</p> <p>Field Date: 8/10/2017</p> <p>Notes: 10/23/17: According to LMA and my observations at LM 1.63, this site never had riprap (contrary to previous comments). Erosion has encroached into levee prism. Future high water and wavewash will likely advance erosion further into prism. Repairs should be made prior to next high water.</p>

10/23/17: According to LMA and my observations at LM 1.63, this site never had riprap (contrary to previous comments). Erosion has encroached into levee prism. Future high water and wavewash will likely advance erosion further into prism. Repairs should be made prior to next high water.

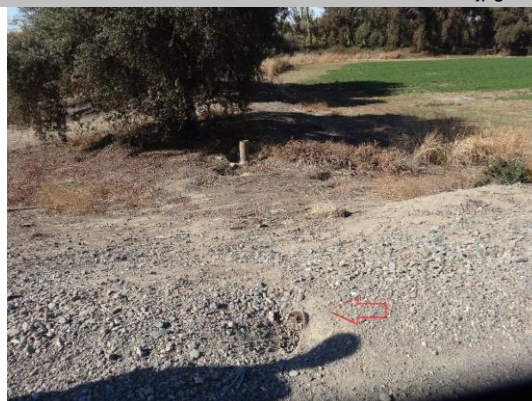
Photo 1 of 3 : UCIP_FA_2018_24666_45600.jpg

Item	DWR UCIP LMA Responsibility		37.731314 °	37.731314 °						
			-121.293713 °	-121.293713 °						
DWR ID	24737									
Comment Code										
Inspector Comment										
<p>FS_ID: 24666</p> <p>DS_ID: 24737</p> <p>EP_NO: N/A</p> <p>Repair Type: Non-Urgent</p> <p>Crossing Status: Found</p> <p>UCIP Comments: - service pole on landside.- looks abandoned.</p> <p>Walkway in dilapidated condition.</p> <p>FIELD_STRUCT_DESC: 16-inch steel drainage discharge pipe through the levee, 4.5 feet below the crown. Corrugated metal cutoff wall. Pump mounted on a pile structure in a drainage ditch on the landside (LS).</p> <p>Siphon breaker in a corrugated metal pipe (CMP) riser on the waterside (WS) slope. [Additional Reference(s): DWR Levee Log, 2005. USACE San Joaquin O&M Manual 3, December 1968, (HLM 2.30)].</p> <p>FS Date: 11/13/2013</p>

WS view: concrete standpipe (top) and steel pipe riser (bottom marked) on levee slope.

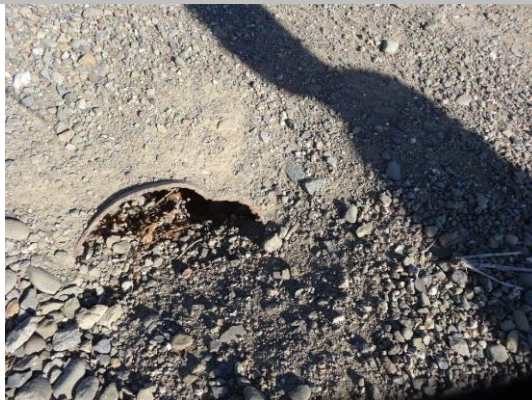
Photo 2 of 3 : UCIP_FA_2018_24666_44030.jpg

Comment Code						
Inspector Comment						
FS_ID:24666						
DS_ID:24737						
EP_NO: N/A						
Repair Type: Non-Urgent						
Crossing Status: Found						
UCIP Comments: - service pole on landside.- looks abandoned.						
Walkway in dilapidated condition.						
FIELD_STRUCT_DESC: 16-inch steel drainage discharge pipe through the levee, 4.5 feet below the crown. Corrugated metal cutoff wall. Pump mounted on a pile structure in a drainage ditch on the landside (LS).						
Siphon breaker in a corrugated metal pipe (CMP) riser on the waterside (WS) slope. [Additional Reference(s): DWR Levee Log, 2005. USACE San Joaquin O&M Manual 3, December 1968, (HLM 2.30)].						
FS Date: 11/13/2013

WS view: blocked siphon breaker in steel pipe riser on levee slope.

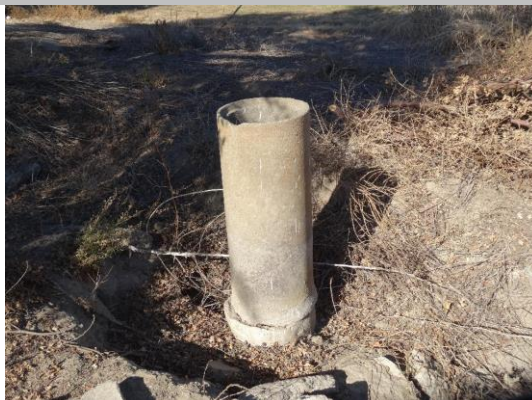
Photo 3 of 3 : UCIP_FA_2018_24666_44029.jpg

WS view: concrete standpipe on levee toe.

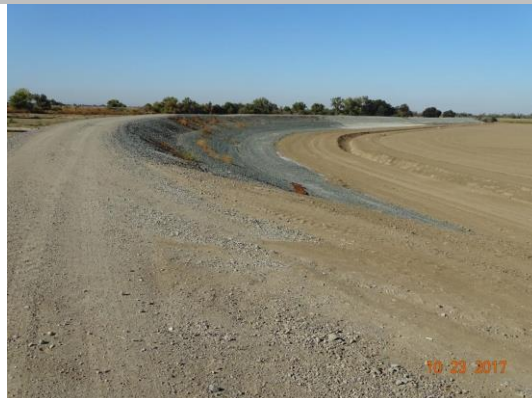
Photo 3 of 3 : FA_2018_RD2075_315_15_20180906_00017.jpg

Item	2017 Storm Damage		37.731200°	37.724900°								
			-121.293400°	-121.293800°								
DWR ID	DWR_RD2075_01_f_2017_15											
Comment Code												
Inspector Comment												
<p>Levee Evaluation Comments Description: Sinkholes have formed along the landside levee toe as a result of the high water. The cause of the sinkholes is not clear, but a similar phenomenon in this area is believed to have caused the levee breach earlier this year. Further geotechnical investigation is needed. Site ID No: 479 Site Designation: LMA-306 Repair Type: Stability Rating: Area of Concern Field Date: 7/26/2017 Notes: Sink holes appear to have already been filled. 10/23/17: LMA has removed pipes (parallel to levee) in this area, and drainage ditch has been relocated to approx 60 feet away from levee toe. Known sandy soils in region may contribute to sinkholes.</p>

10/23/17: LMA has removed pipes (parallel to levee) in this area, and drainage ditch has been relocated to approx 60 feet away from levee toe. Known sandy soils in region may contribute to sinkholes.

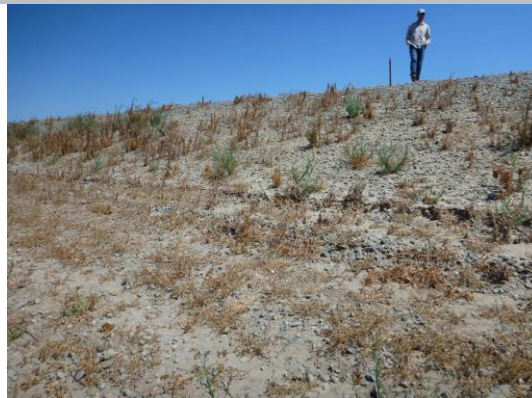
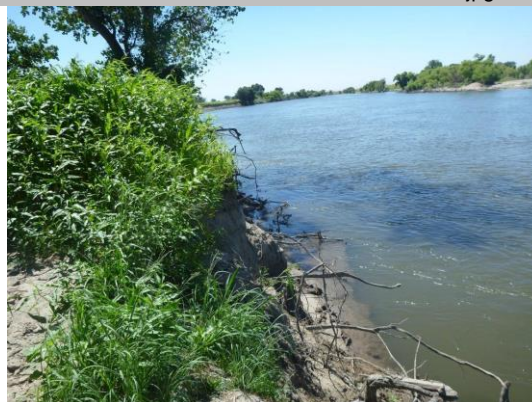
Item	2017 Storm Damage		37.725200°	37.724000°								
			-121.294400°	-121.293200°								
DWR ID	DWR_RD2075_01_f_2017_16											
Comment Code												
Inspector Comment												
<p>Levee Evaluation Comments Description: Slope protection repairs are needed along the waterside slope due to erosion. Based upon levee inspections, it was determined the waterside levee slopes were eroding, deteriorating and degrading in concave pocket sections at various locations along this levee reach. The eroded levee sections need to be restored back to design standards to prevent further deterioration of the damaged levee sections. Site ID No: 480 Site Designation: LMA-307 Repair Type: Erosion Rating: Area of Concern Field Date: 7/26/2017 Notes: Low priority because of the wide berm. Could not see all of the bank because of vegetation. Rock was placed on LS here during this years (2017) storms.</p>

LM Start	2.74	Rating **	A/W	Issue No.	16 (cont)
LM End	2.84	Issue Type +	Ma	Location *	WS
Category	Supplemental			GPS Latitude/Longitude	
				Start	End
Item	2017 Storm Damage			37.725200 °	37.724000 °
				-121.294400 °	-121.293200 °
DWR ID	DWR_RD2075_01_f_2017_16				
Comment Code

Description: Slope protection repairs are needed along the waterside slope due to erosion. Based upon levee inspections, it was determined the waterside levee slopes were eroding, deteriorating and degrading in concave pocket sections at various locations along this levee reach. The eroded levee sections need to be restored back to design standards to prevent further deterioration of the damaged levee sections.

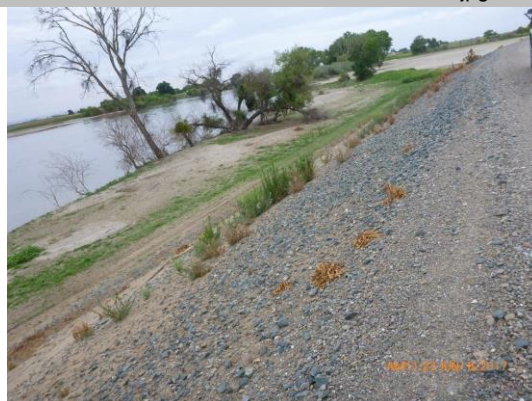
LM Start	2.77	Rating **	A/W	Issue No.	14
LM End	2.83	Issue Type +	Ma	Location *	WS
Category	Supplemental			GPS Latitude/Longitude	
				Start	End
Item	2017 Storm Damage			37.724810 °	37.724207 °
				-121.294150 °	-121.293308 °
DWR ID	DWR_RD2075_01_f_2017_14

Notes: no damage present 10/23/17: Photos taken of vertical eroded low-flow bank approximately 20 feet from waterside levee toe. Area is composed of loose sand. Sandbar in channel may direct current toward this area.

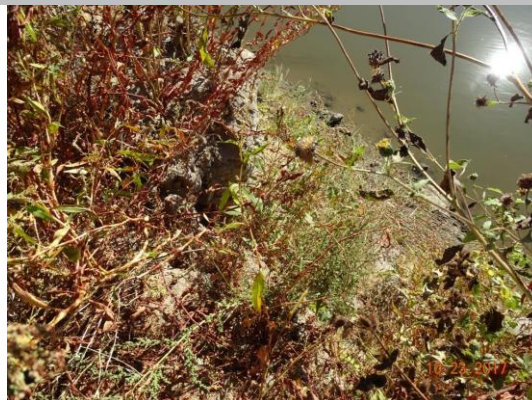
Photo 4 of 6 : FA_2018_RD2075_315_14_20180906_00012.jpg

View down through erosion rut in bank. 10/23/17: Photos taken of vertical eroded low-flow bank approximately 20 feet from waterside levee toe. Area is composed of loose sand. Sandbar in channel may direct current toward this area.

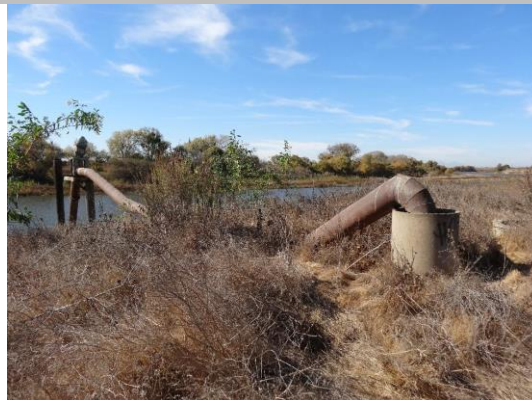
Photo 1 of 3 : UCIP_FA_2018_41721_45982.jpg

Comment Code						
Inspector Comment						
FS_ID:41721						
DS_ID:24746						
EP_NO: N/A						
Repair Type: Non-Urgent						
Crossing Status: Found						
UCIP Comments: Several concrete structure with Alfalfa valve. Only steel pipe visible on river bank. Service pole on waterside.New field discovered crossing.						
FIELD_STRUCT_DESC: 10-inch polyvinyl chloride (PVC) irrigation discharge pipe through the levee, at an unknown depth. Slant pump on the riverbank. Distribution box on the waterside (WS) berm. Concrete U-shaped headwall and open outlet on the landside (LS) toe. Crossing was field discovered. (Plans to install a slant pump on the riverbank authorized under Permit No. 5484, 1966 - Jack Clinton).						
FS Date: 11/13/2013

WS view: slant pump and concrete distribution box on levee berm.

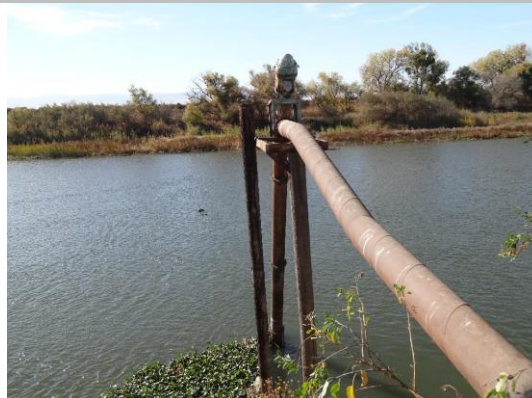
Photo 2 of 3 : UCIP_FA_2018_41721_45981.jpg

WS view: slant pump on timber pile in the stream.

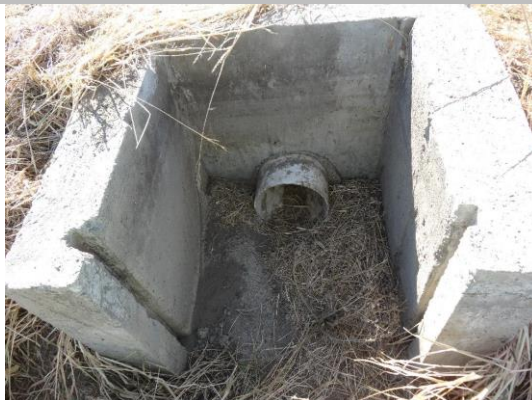
Photo 3 of 3 : UCIP_FA_2018_41721_45980.jpg

Comment Code						
Inspector Comment						
FS_ID:41721						
DS_ID:24746						
EP_NO: N/A						
Repair Type: Non-Urgent						
Crossing Status: Found						
UCIP Comments: Several concrete structure with Alfalfa valve. Only steel pipe visible on river bank. Service pole on waterside.New field discovered crossing.						
FIELD_STRUCT_DESC: 10-inch polyvinyl chloride (PVC) irrigation discharge pipe through the levee, at an unknown depth. Slant pump on the riverbank. Distribution box on the waterside (WS) berm. Concrete U-shaped headwall and open outlet on the landside (LS) toe. Crossing was field discovered. (Plans to install a slant pump on the riverbank authorized under Permit No. 5484, 1966 - Jack Clinton).						
FS Date: 11/13/2013

LS view: concrete U type headwall on levee toe and open PVC pipe.

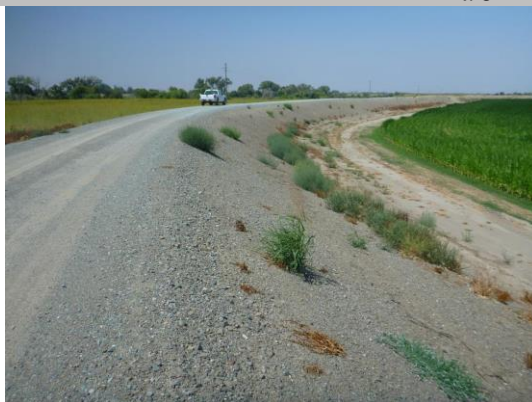
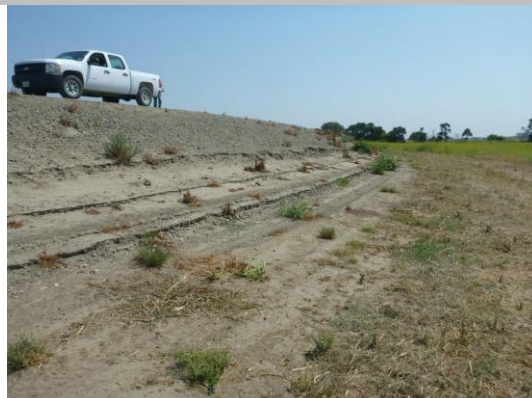
LM Start	3.90	Rating **	A/W	Issue No.	18
LM End	3.95	Issue Type +	Ma	Location *	WS
Category	Supplemental			GPS Latitude/Longitude	
				Start	End
Item	2017 Storm Damage			37.713388 °	37.713492 °
				-121.280018 °	-121.278982 °
DWR ID	DWR_RD2075_01_f_2017_18

Comment Code					
Inspector Comment					
Levee Evaluation Comments					
Description:Slope protection repairs are needed along the waterside slope due to erosion and riprap displacement from high water. Based upon levee inspections, it was determined the waterside levee slope is eroding, deteriorating, and degrading. The eroded levee sections need to be restored back to design standards to prevent further deterioration and damage.					
Site ID No:576					
Site Designation:LMA-482					
Repair Type: Erosion					
Rating:Area of Concern					
Field Date:8/10/2017					
Notes: 10/23/17: There was no riprap in this area. Erosion sites have been repaired by LMA.

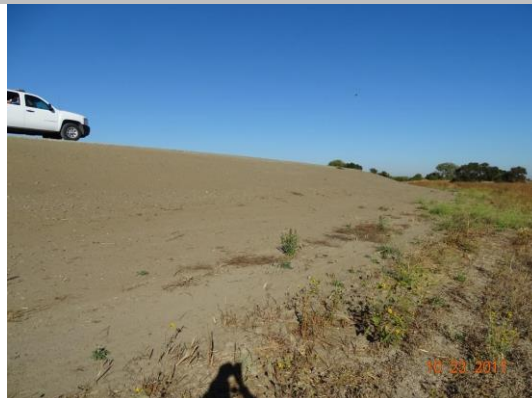
Photo 4 of 4 : FA_2018_RD2075_315_18_20180906_00025.jpg

10/23/17: There was no riprap in this area (contrary to previous comment). Erosion sites have been repaired by LMA.

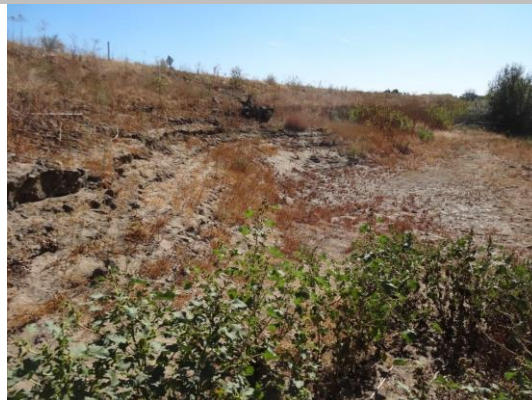
Photo 3 of 3 : FA_2018_RD2075_315_1_20180906_00003.jpg

Looking upstream at the site.

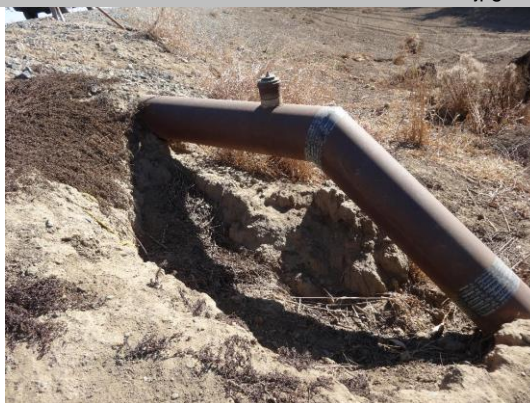
Photo 1 of 3 : UCIP_FA_2018_50191_44262.jpg

WS view: siphon breaker on steel pipe on levee slope. Huge soil erosion due to siphon breaker leakage.

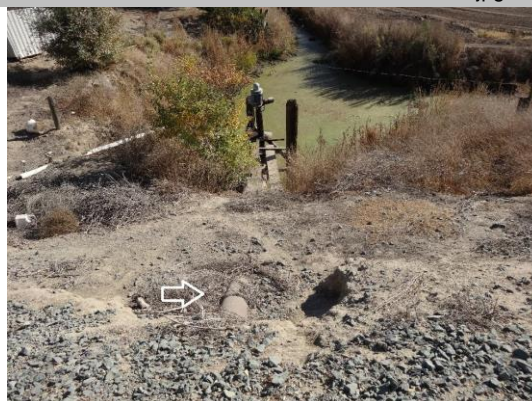
Photo 3 of 3 : UCIP_FA_2018_50213_45614.jpg

LS view: deformed pipe and soil erosion around it (marked bottom). Pipe and pump on pile structure in drain ditch.
